Manhole Inspection Summary

Manhole # S11CC1012MH

Location Address: **4000 EDGEWOOD RD**

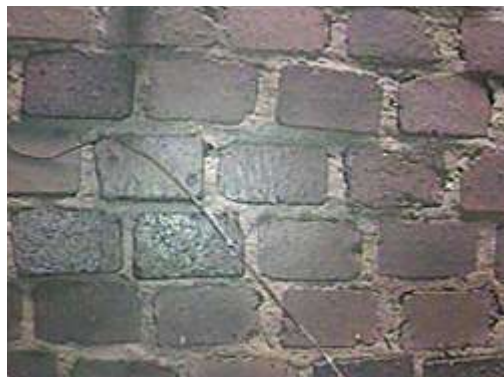
Defect 1

Condition: ☐ Sound ☒ **Cracked** ☐ Root Intrusion ☒ **Loose Brick** ☒ **Deteriorated**

ROOT INTRUSION, LOOSE BRICKS
AND CRACKS IN BARREL

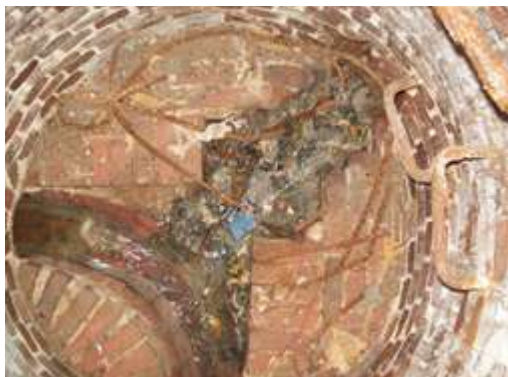
Defect 5

Condition: ☐ Sound ☒ **Cracked** ☐ Root Intrusion ☒ **Deteriorated** ☐ Leaks ☐ Debris

DETERIORATION, CRACKS DEBRIS ON
BENCH

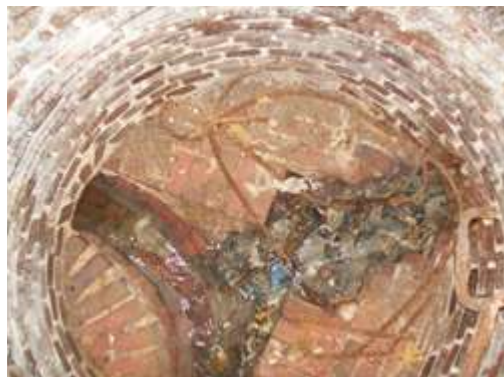
Defect 4

Condition: ☐ Sound ☐ Cracked ☐ Root Intrusion ☒ **Deteriorated** ☐ Leaks ☒ **Debris**

CHANNEL DETERIORATION AND
DEBRIS

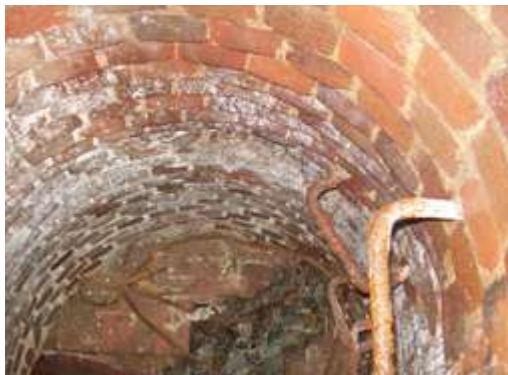
Defect 3

Count: **4** Missing: **0** ☒ **Corroded**

CORRODED STEPS

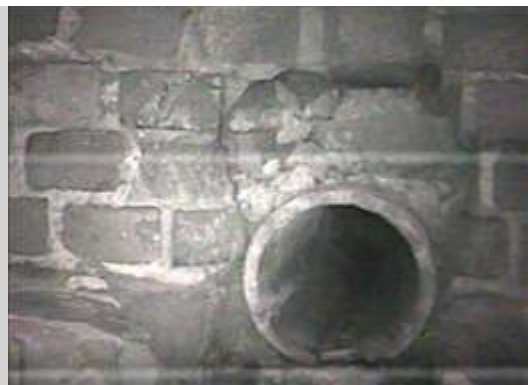
8 O'Clock Inflow

Pipe Seal Cond: **Cracked**
